Report Geotechnical Engineering Services Preliminary Coal Mine Hazard Assessment King County Parcel Nos. 332406-9029, -9036, -9039,-9045 and -9066 Issaquah, Washington

July 7, 2015 ICE File No. 1131-001

Prepared For: Boardwalk Real Estate LLC

Prepared By: Icicle Creek Engineers, Inc.

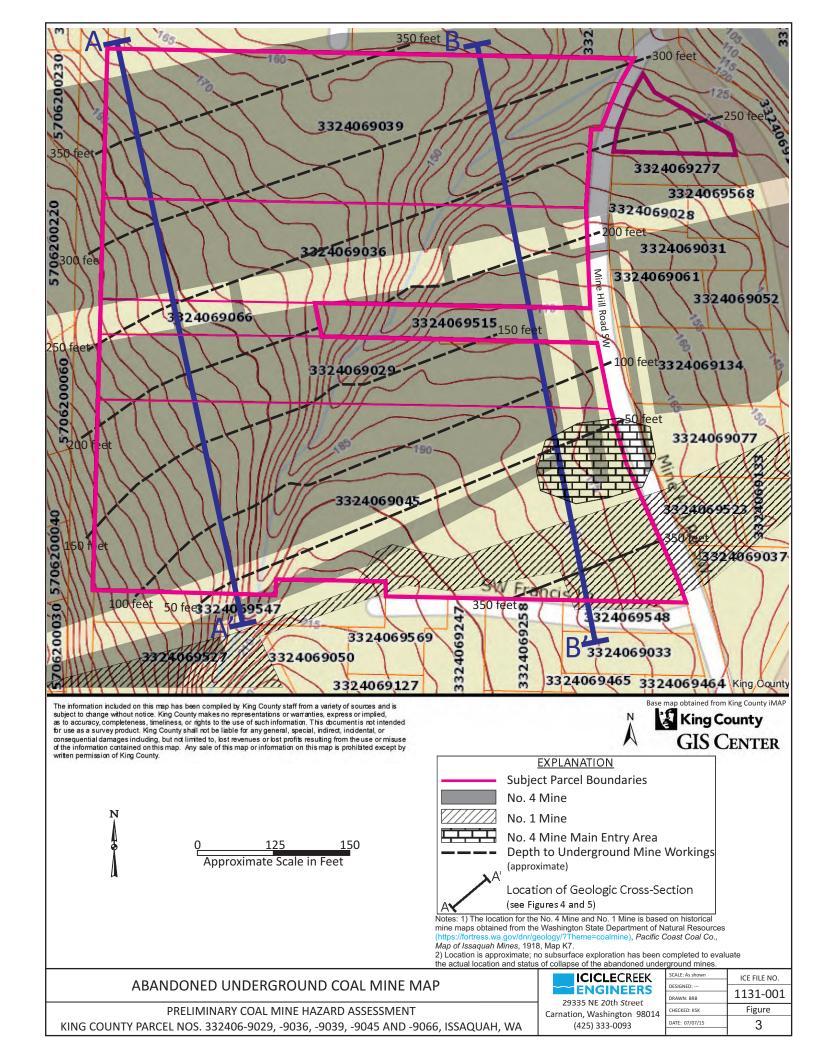
Abandoned Underground Coal Mine Map - Figure 3

Within the study area for this report, the abandoned No. 4 Mine underlies all five parcels, and the abandoned No. 1 Mine underlies the southeast corner of the southernmost parcel (Parcel No. 332406-9045) as shown on the Abandoned Underground Coal Mine Map, Figure 3 and Geologic Cross-Sections A-A' and B-B', Figures 4 and 5, respectively. Based on our review and evaluation, abandoned underground coal mine(s) underlie the parcels (from south to north) at an approximate depth as follows.

Based on our review of the 1984 Goodson study, the nearest reported surface subsidence feature is related to shallow workings and the Mine Entries (there were three) to the No. 4 Mine in the northeast

corner of Parcel No. 332406-9045 as shown on Figure 3 (referred to as "WAO 120" in the 1984 Goodson study). WAO 120 is described as "a main slope portal, two slope air chutes and an adit portal to the No. 4 seam workings." At the time of the 1984 Goodson study, the subsidence area was described as covered, though a large depression was observed.

We did not observe any topographic depressions on the subject parcels or other ground surface irregularities that may be associated with past mining activities. However, the area of WAO 120 is currently a pasture area and exhibits a subtle depression consistent with the description in the 1984 Goodson study.

Based on our site observations and historical mine records review, the No. 4 Mine underlies parts of Parcel Nos. 332406-9029 and -9045 at depths of less than 150 feet as shown on Figure 3 and is therefore within a Severe Coal Mine Hazard Area as shown on the Coal Mine Hazard Areas Map, Figure 6.

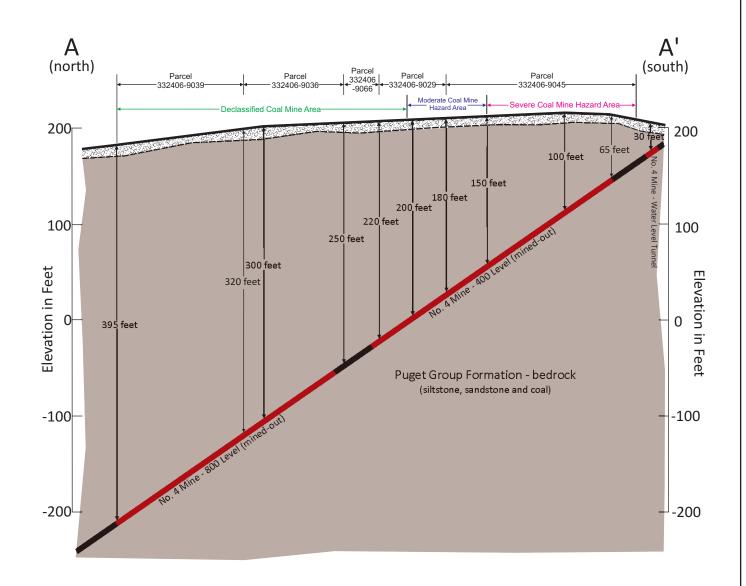
GEOLOGIC CROSS-SECTION A-A'

- The abandoned No. 4 Mine underlies all five parcels, and the No. 1 Mine underlies the southeast corner of the southernmost parcel (Parcel No. 332406-9045) as shown on Figures 3, 4 and 5.

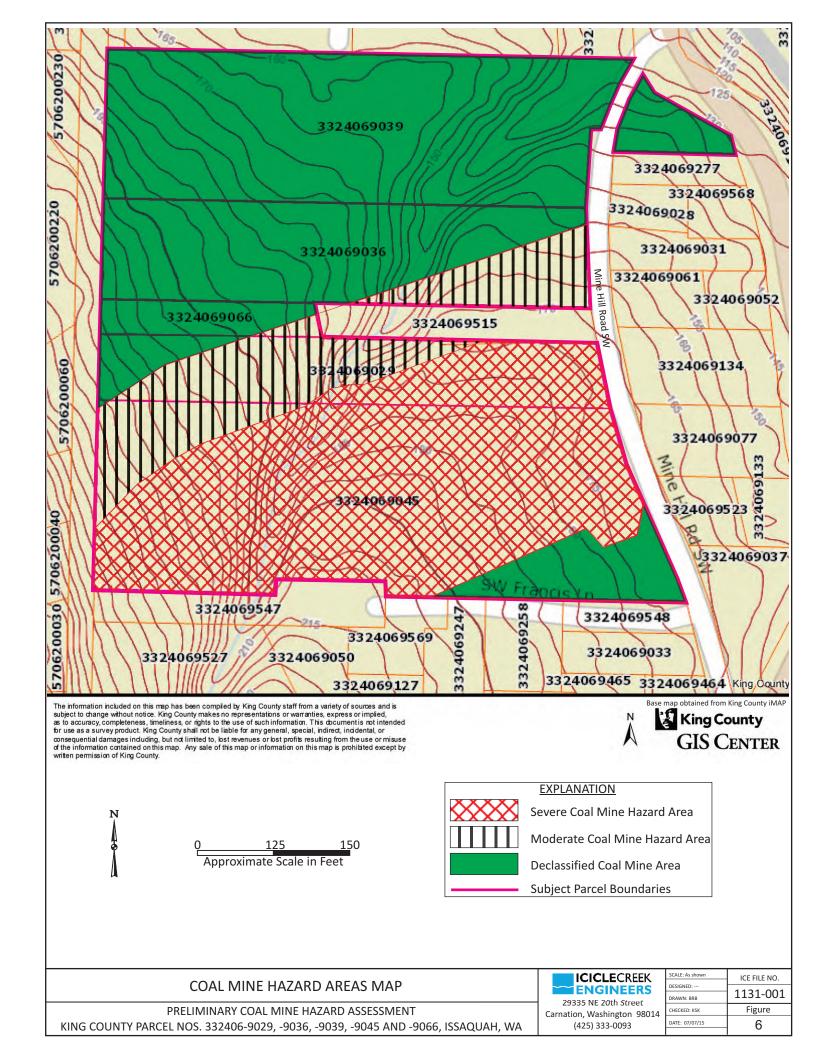
Geologic Cross-Section A-A' - Figure 4 Geologic Cross-Section B-B' - Figure 5 Coal Mine Hazard Areas Map - Figure 6

Moderate Coal Mine Hazard Areas occur where 1) ground tilt is in excess of 1:350, that is, 1 foot of vertical settlement in 350 horizontal feet, and/or 2) ground strain is in excess of 0.003 inches per inch. Based on our analysis, total potential regional ground subsidence is estimated to be about 27½ inches. Maximum ground tilt and strain across the central part of the subject parcel area are more than the defined thresholds for structural damage and is considered a Moderate Coal Mine Hazard Area as shown on Figure 6.

At this time, the areas south of the Severe Coal Mine Hazard Area (southeast corner of Parcel No. 332406-9045) and north of the Moderate Coal Mine Hazard Areas should be considered a Declassified Coal Mine Area as shown on Figure 6.

- Based on our site observations and historical mine records review, the No. 4 Mine underlies parts of Parcel Nos. 332406-9029 and -9045 as shown on Figure 3 and is therefore within a Severe Coal Mine Hazard Area as shown on the Coal Mine Hazard Areas Map, Figure 6.

- The area crossing the central part of the subject parcels should be considered a Moderate Coal Mine Hazard Area as shown on Figure 6.
- The areas south of the Severe Coal Mine Hazard Area (southeast corner of Parcel No. 332406-9045)
 and north of the Moderate Coal Mine Hazard Area should be considered a Declassified Coal Mine
 Area as shown on Figure 6.

No residential development should occur within the Severe Coal Mine Hazard Area. Passive use should be allowed such as pasture or lawn/landscaped areas.

Residential use within the Moderate Coal Mine Hazard Area should be allowed provided that the following mitigations for design and construction are implemented.

- Use of rigid foundations (conventional reinforced concrete spread footings) supporting a flexible superstructure (wood-frame).
- Small, square or nearly square-shaped building pads should be favored over large, irregularly-shaped building pads.
- Crawl-space construction rather than slab-on-grade. However, slab-on-grade may be used in garage and driveway areas.
- Buildings should be constructed such that they could be easily releveled.
- No brick or basement construction.
- Edges of foundations should be backfilled with loose soil or other compressible material to allow for potential ground compression.
- Underground utilities should be designed with flexible and/or telescopic couplings or fittings.
- Utilities that depend on gravity for flow (sewers and storm drain) should be designed to compensate for the potential for ground subsidence.
